Reducing Motor Bearing Failures – Modified Lubrication Procedures Improve Reliability at TVA

Jerry Honeycutt,
Tennessee Valley Authority

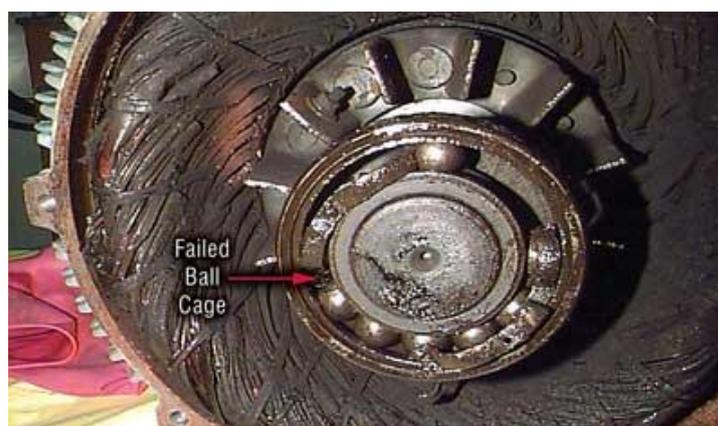
All of TVA’s nuclear sites use NP-7502 for regreasing guidelines. Practices used prior to the adoption of the new guideline resulted in overfilling several motors. Subsequent actions required by NP-7502 served to further pressurize grease cavities of the bearing housings, in some cases to the extent that bearing shields were pressed into the ball cage of the rolling elements, resulting in the failure of shields and bearings.

An example of a bearing failure due to bearing shields being pushed into the raceway as a consequence of overgreasing is shown in Figure 1.

Install a pressure-sensitive (20 psi differential) grease-fill fitting that will not allow the cavity to be pressurized beyond 20 psi. This should minimize excessive pressure buildup on the bearing shield while the motor is being regreased.

Install a grease-relief valve-fitting to take the place of the grease drain plug. The grease-relief valve will open between 1 and 5 psi and will minimize risk of over-pressurization of the grease cavity from re-lubrication and thermal expansion of the grease (while running the motor).

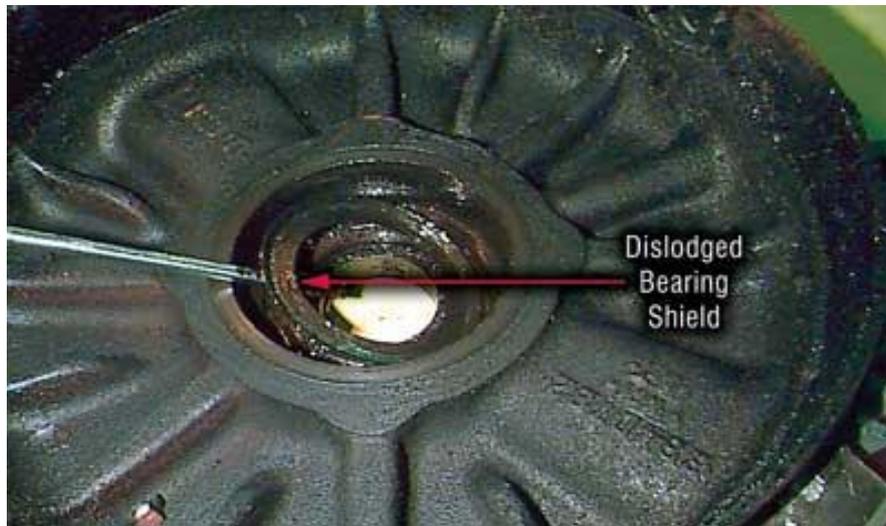
Figure 2.

This was a control rod drive (CRD) fan motor at Watts Bar Nuclear Plant. The bearing experienced a ball cage failure due to the bearing shield (Figure 2) being pushed down on the ball cage due to overpressurization of the grease cavity.

End bell with bearing shield that has become dislodged from the bearing.
